SAFETY NOTICE AND REPLACEMENT PROGRAM

BLACKHAWK! SERPA Level 3 Light Bearing Duty Holsters (Manufactured Before October 2011)

February 7, 2012

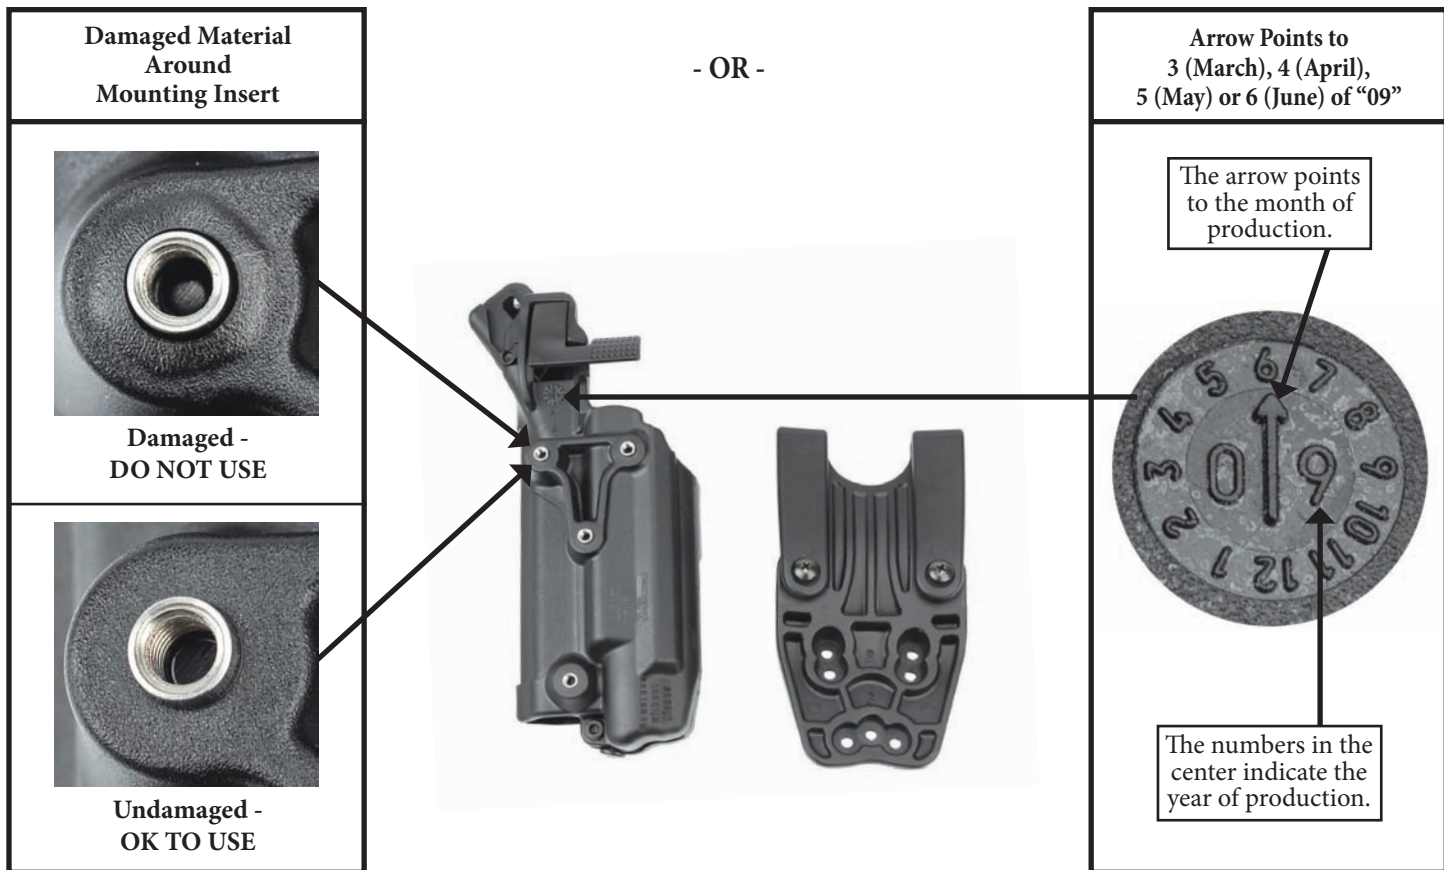
BLACKHAWK! has received reports of SERPA **LIGHT BEARING** duty holsters detaching from their mounting platform under certain conditions. This generally occurs if the user damages the material surrounding the screw insert (see picture below) by using extreme force when tightening the mounting screws or by mounting the holster using incorrect or missing screws. In addition, a small number of **LIGHT BEARING** holsters manufactured in March-June of 2009 may contain parts that can contribute to this condition.

To see if your holster is affected, remove the mounting platform and inspect the back. **DO NOT USE** your Light Bearing holster if either of the following apply:

Although this condition only affects a limited number of holsters, to prevent future damage from occurring BLACKHAWK! recommends you replace your holster, and is offering a free upgrade for all owners of SERPA **LIGHT BEARING** holsters manufactured before October 2011. If your **LIGHT BEARING** holster qualifies under this program, visit www.blackhawk.com and follow the instructions, e-mail BLACKHAWK! at lbholsterreplacement@blackhawk.com or call customer service at 800-694-5263. We will pay for all shipping costs.

For all holsters, BLACKHAWK! would like to remind its customers to never use a holster with a missing mounting screw and to never use the longer screw without the spacer in place.
